Suncor Energy (U.S.A.) Inc.

Investigation Findings and Responsive Actions

Type of Event: Commerce City Refinery Cold Weather and Shutdown Events

Dates of Events: December 21, 2022 to January 3, 2023

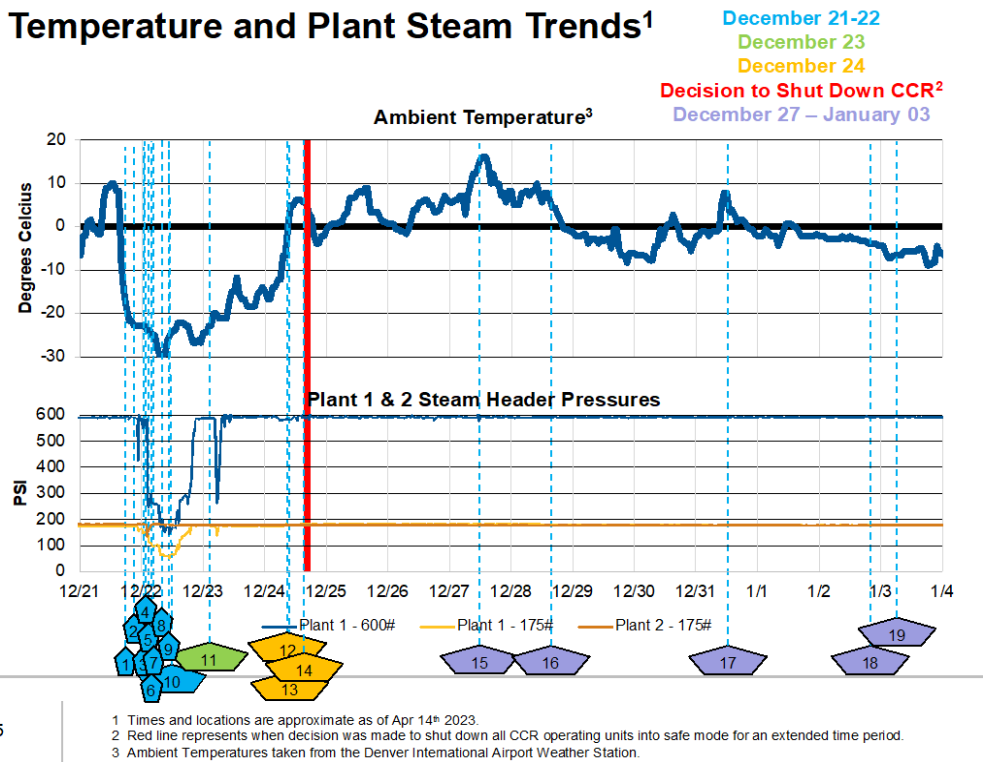
Figure 3., Refinery Ambient Temperatures Trend, Plants Stream Trends, Shutdown Decision (Red Line), and 19 Cold Weather and Shutdown Events—December 21, 2022, to January 4, 2023.

Figure 3., depicts two graphs with four trend lines from December 21, 2022, to January 4, 2023. The upper graph depicts the ambient temperature experienced in Denver, Colorado, where the Refinery operates. The lower graph illustrates the steam header pressure in pounds per square inch-gauge (the “psig”) for both Plant 1 (and 3) and Plant 2. Figure 3., also depicts the 19 Events included in this report; see Table 2., above for the associated color coding. The red vertical line depicted in Figure 3., denotes when the Refinery leadership team chose to shutdown all operating units at the Refinery for the Events.
