Sears Canada Inc. Updated Site Management Plan (2014) Groundwater Monitoring Well Abandonment Locations Report Hounsfield Heights and North Hill Mall, Calgary, Alberta

Updated Site Management Plan (2014)
Groundwater Monitoring Well Abandonments Report
Hounsfield Heights – Briar Hill Community
Calgary, Alberta

CG2430E03

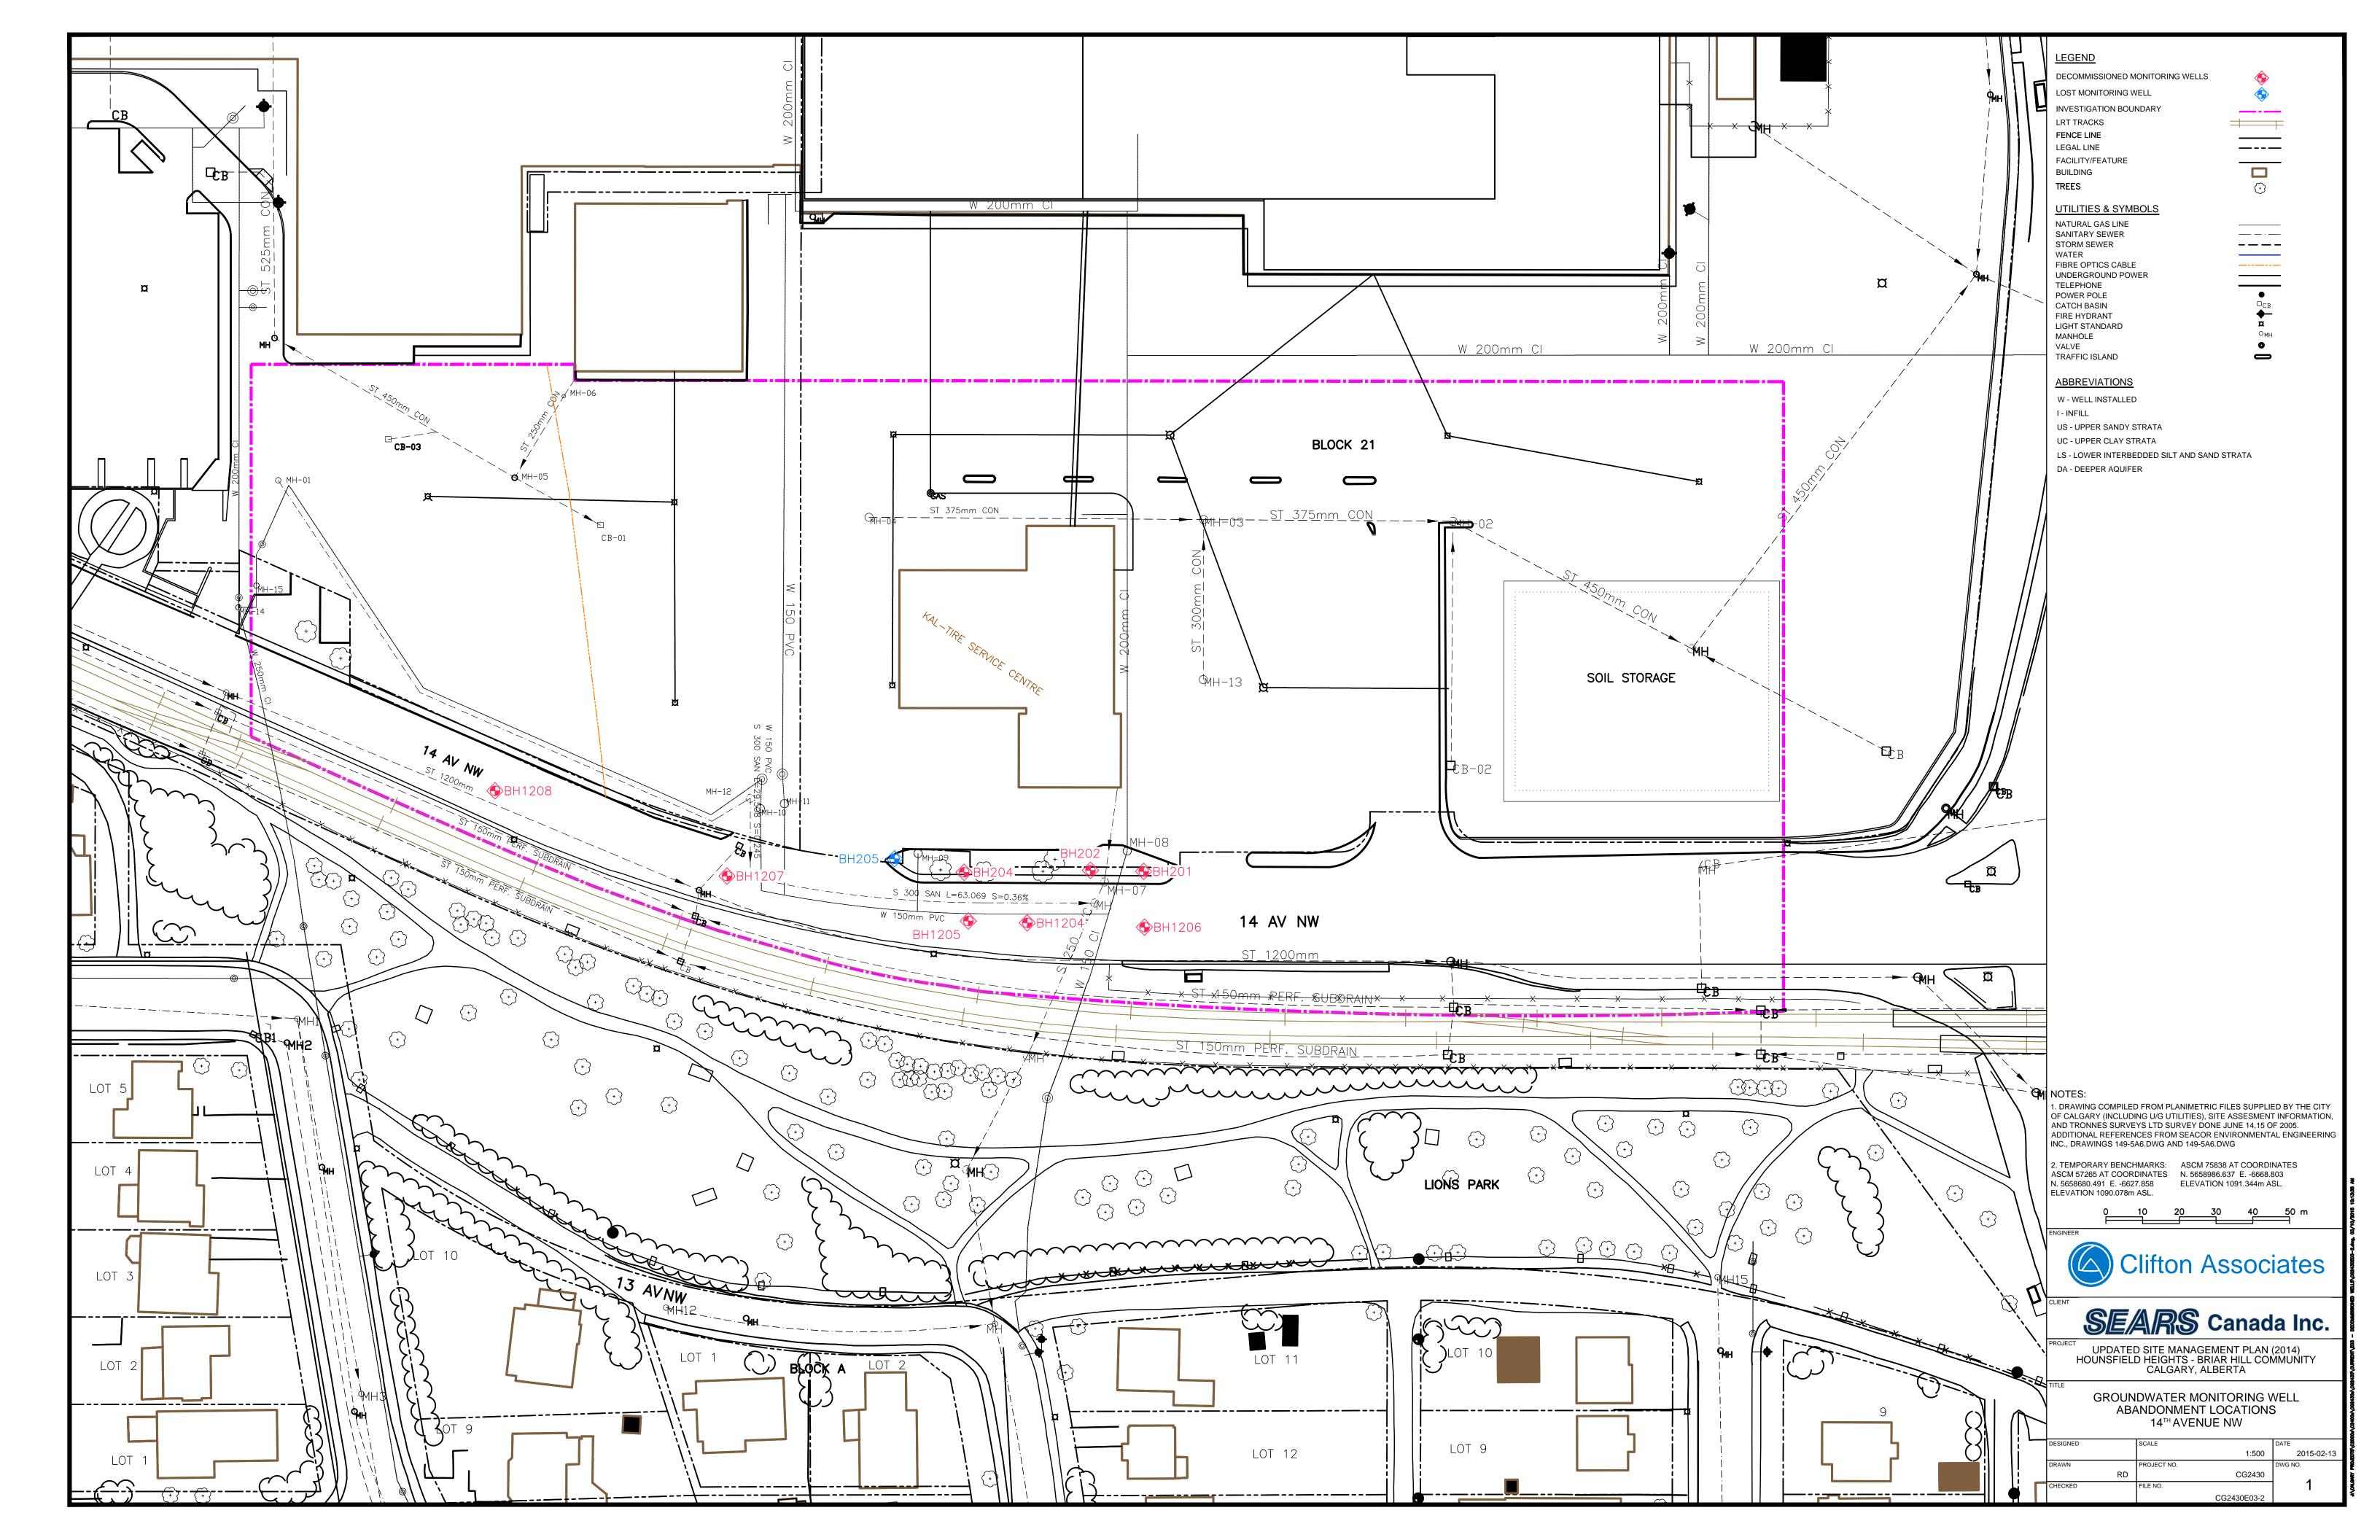
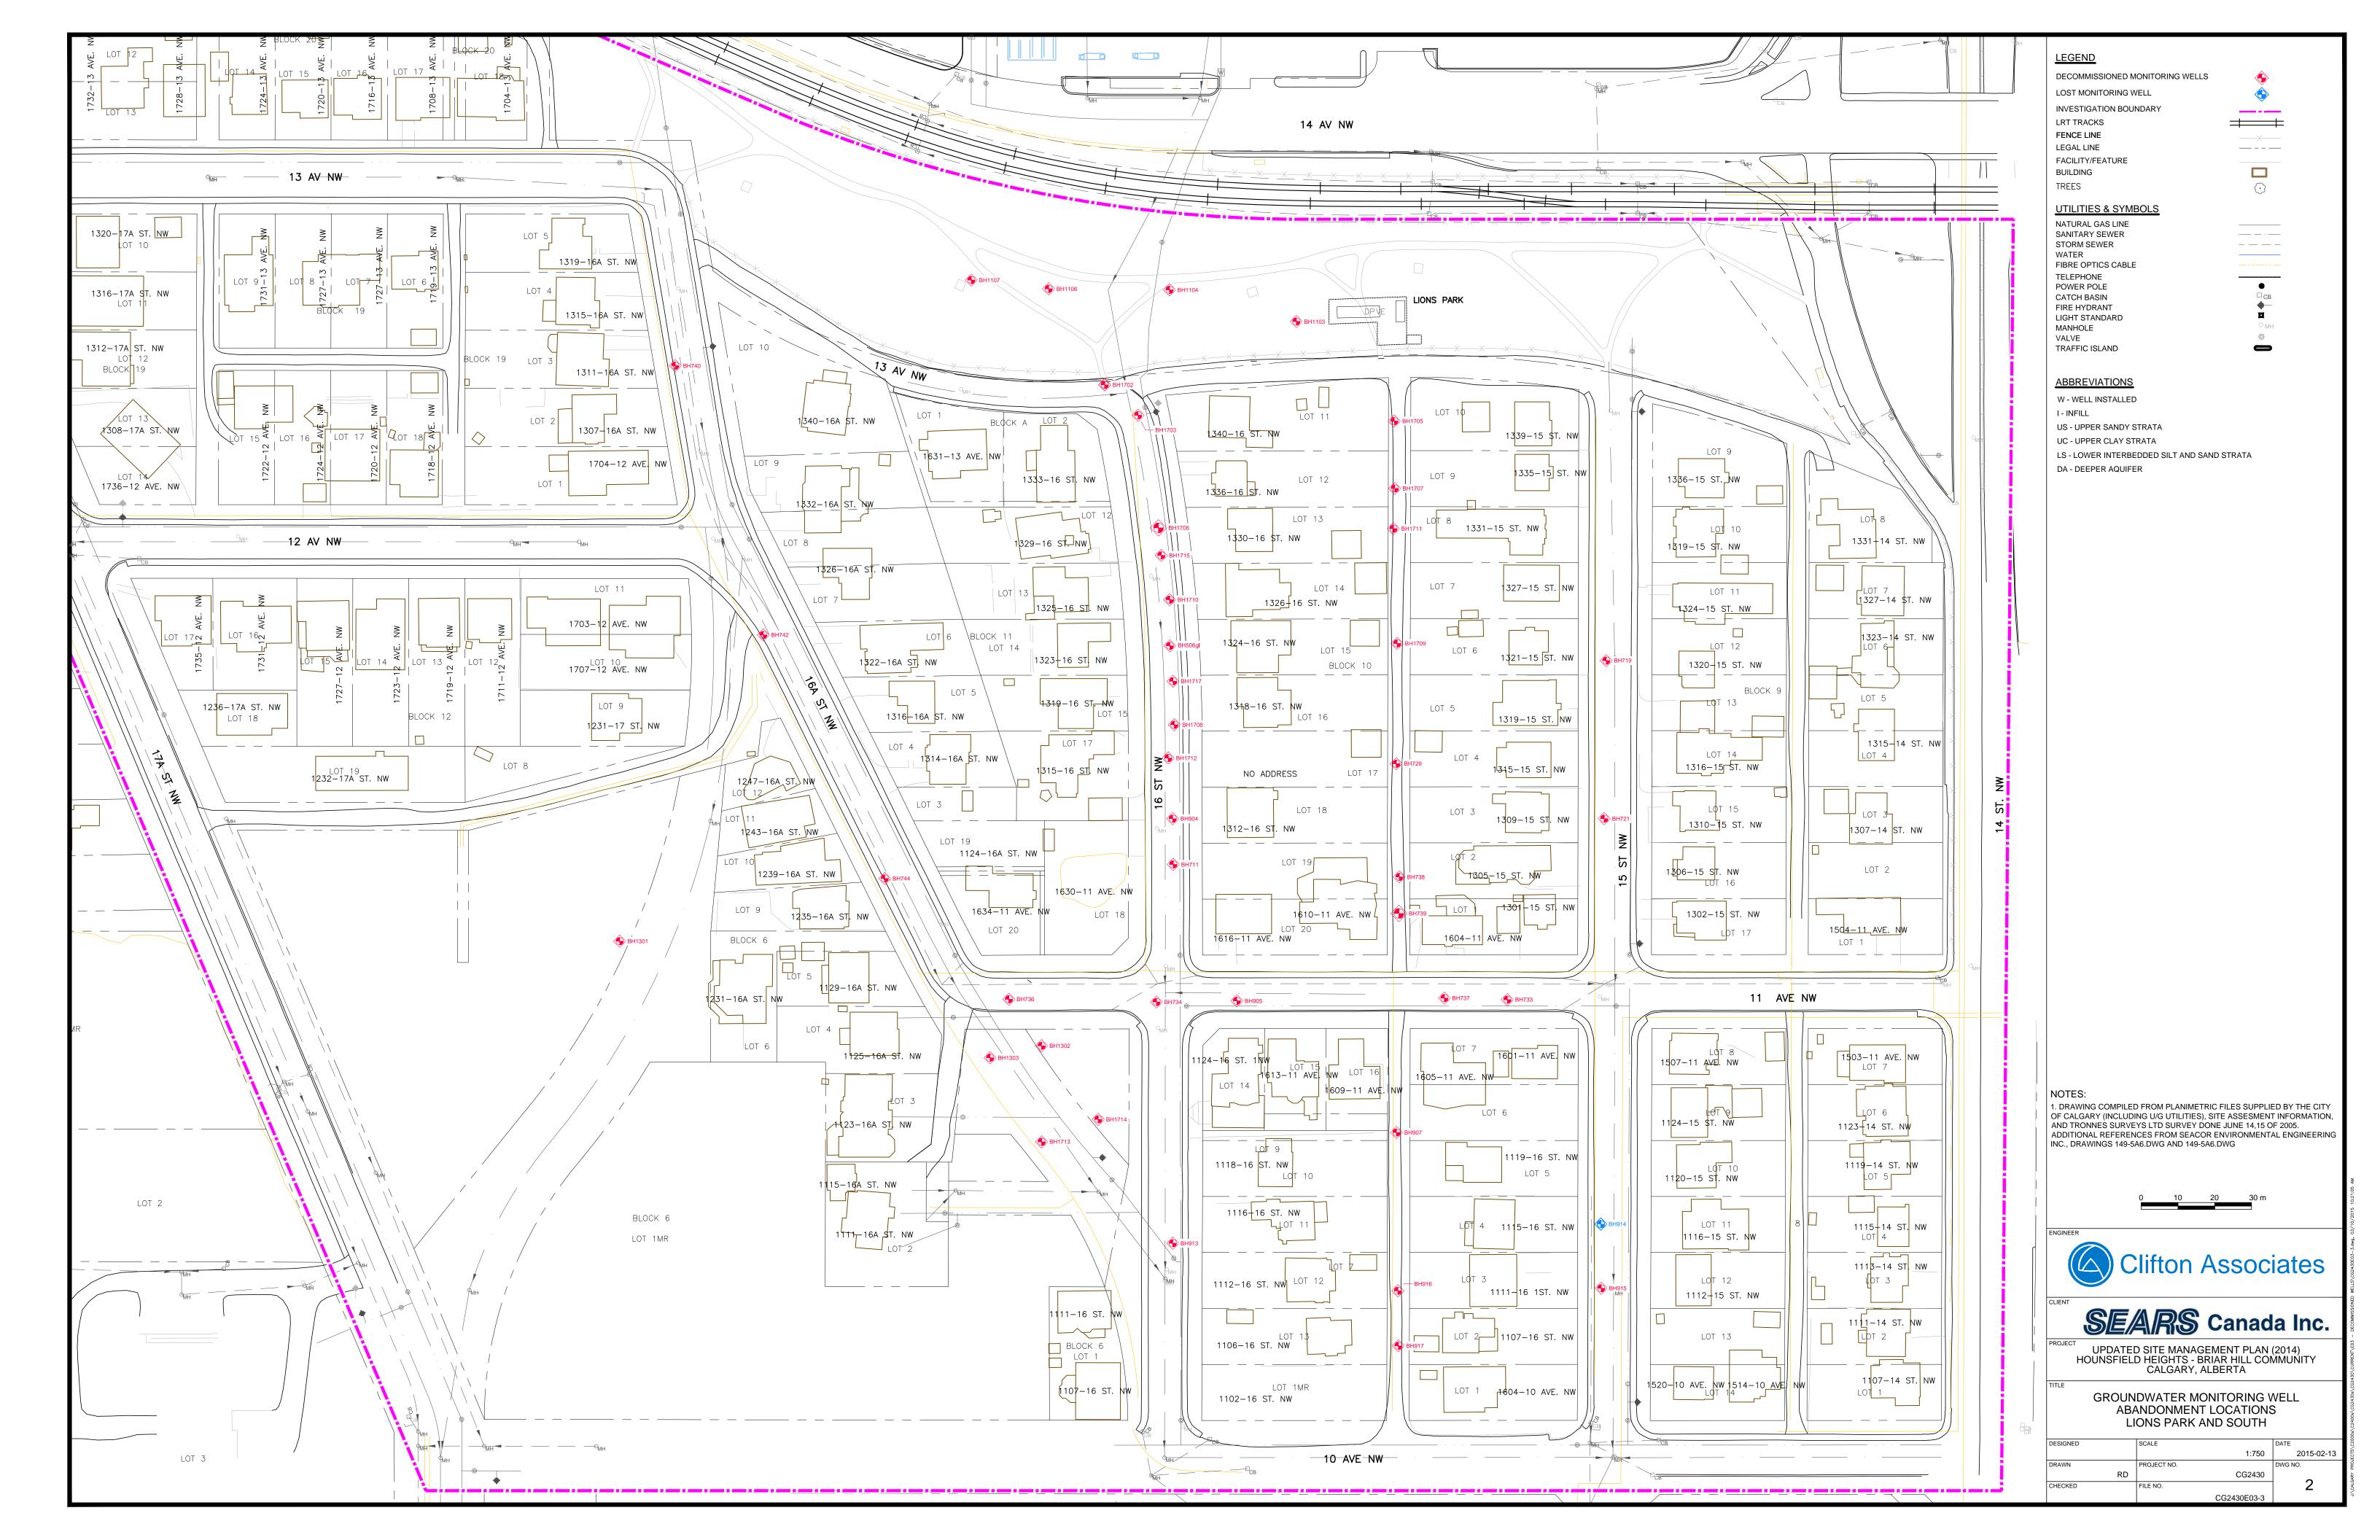
The locations of the abandoned wells are shown in Figures 1 and 2 of Appendix A.

The process of the well identification started with a field verification of well locations by Clifton personnel, and comparing locations of the wells against historic records and maps. Due to the significant age of some of the wells, in numerous instances wells were found to be obstructed by a new layer of asphalt, concrete, gravel, and/or asphalt chips. In these cases, Clifton deployed a metal detector and Ground Penetrating Radar (GPR) to facilitate localization of the obstructed wells. Despite Clifton's best efforts, in the case of two groundwater monitoring wells (BH-205 and BH-914) all attempts at their localization were unsuccessful. These wells are marked as lost (blue) on Figures 1 and 2 in Appendix A.
