**Suncor Energy Adelaide Wind
Power Project - Renewable
Energy Approval Amendment
Modification Report**

File No. 160960710

Prepared by:
Stantec Consulting Ltd.
1-70 Southgate Drive
Guelph ON N1G 4P5

November 2013

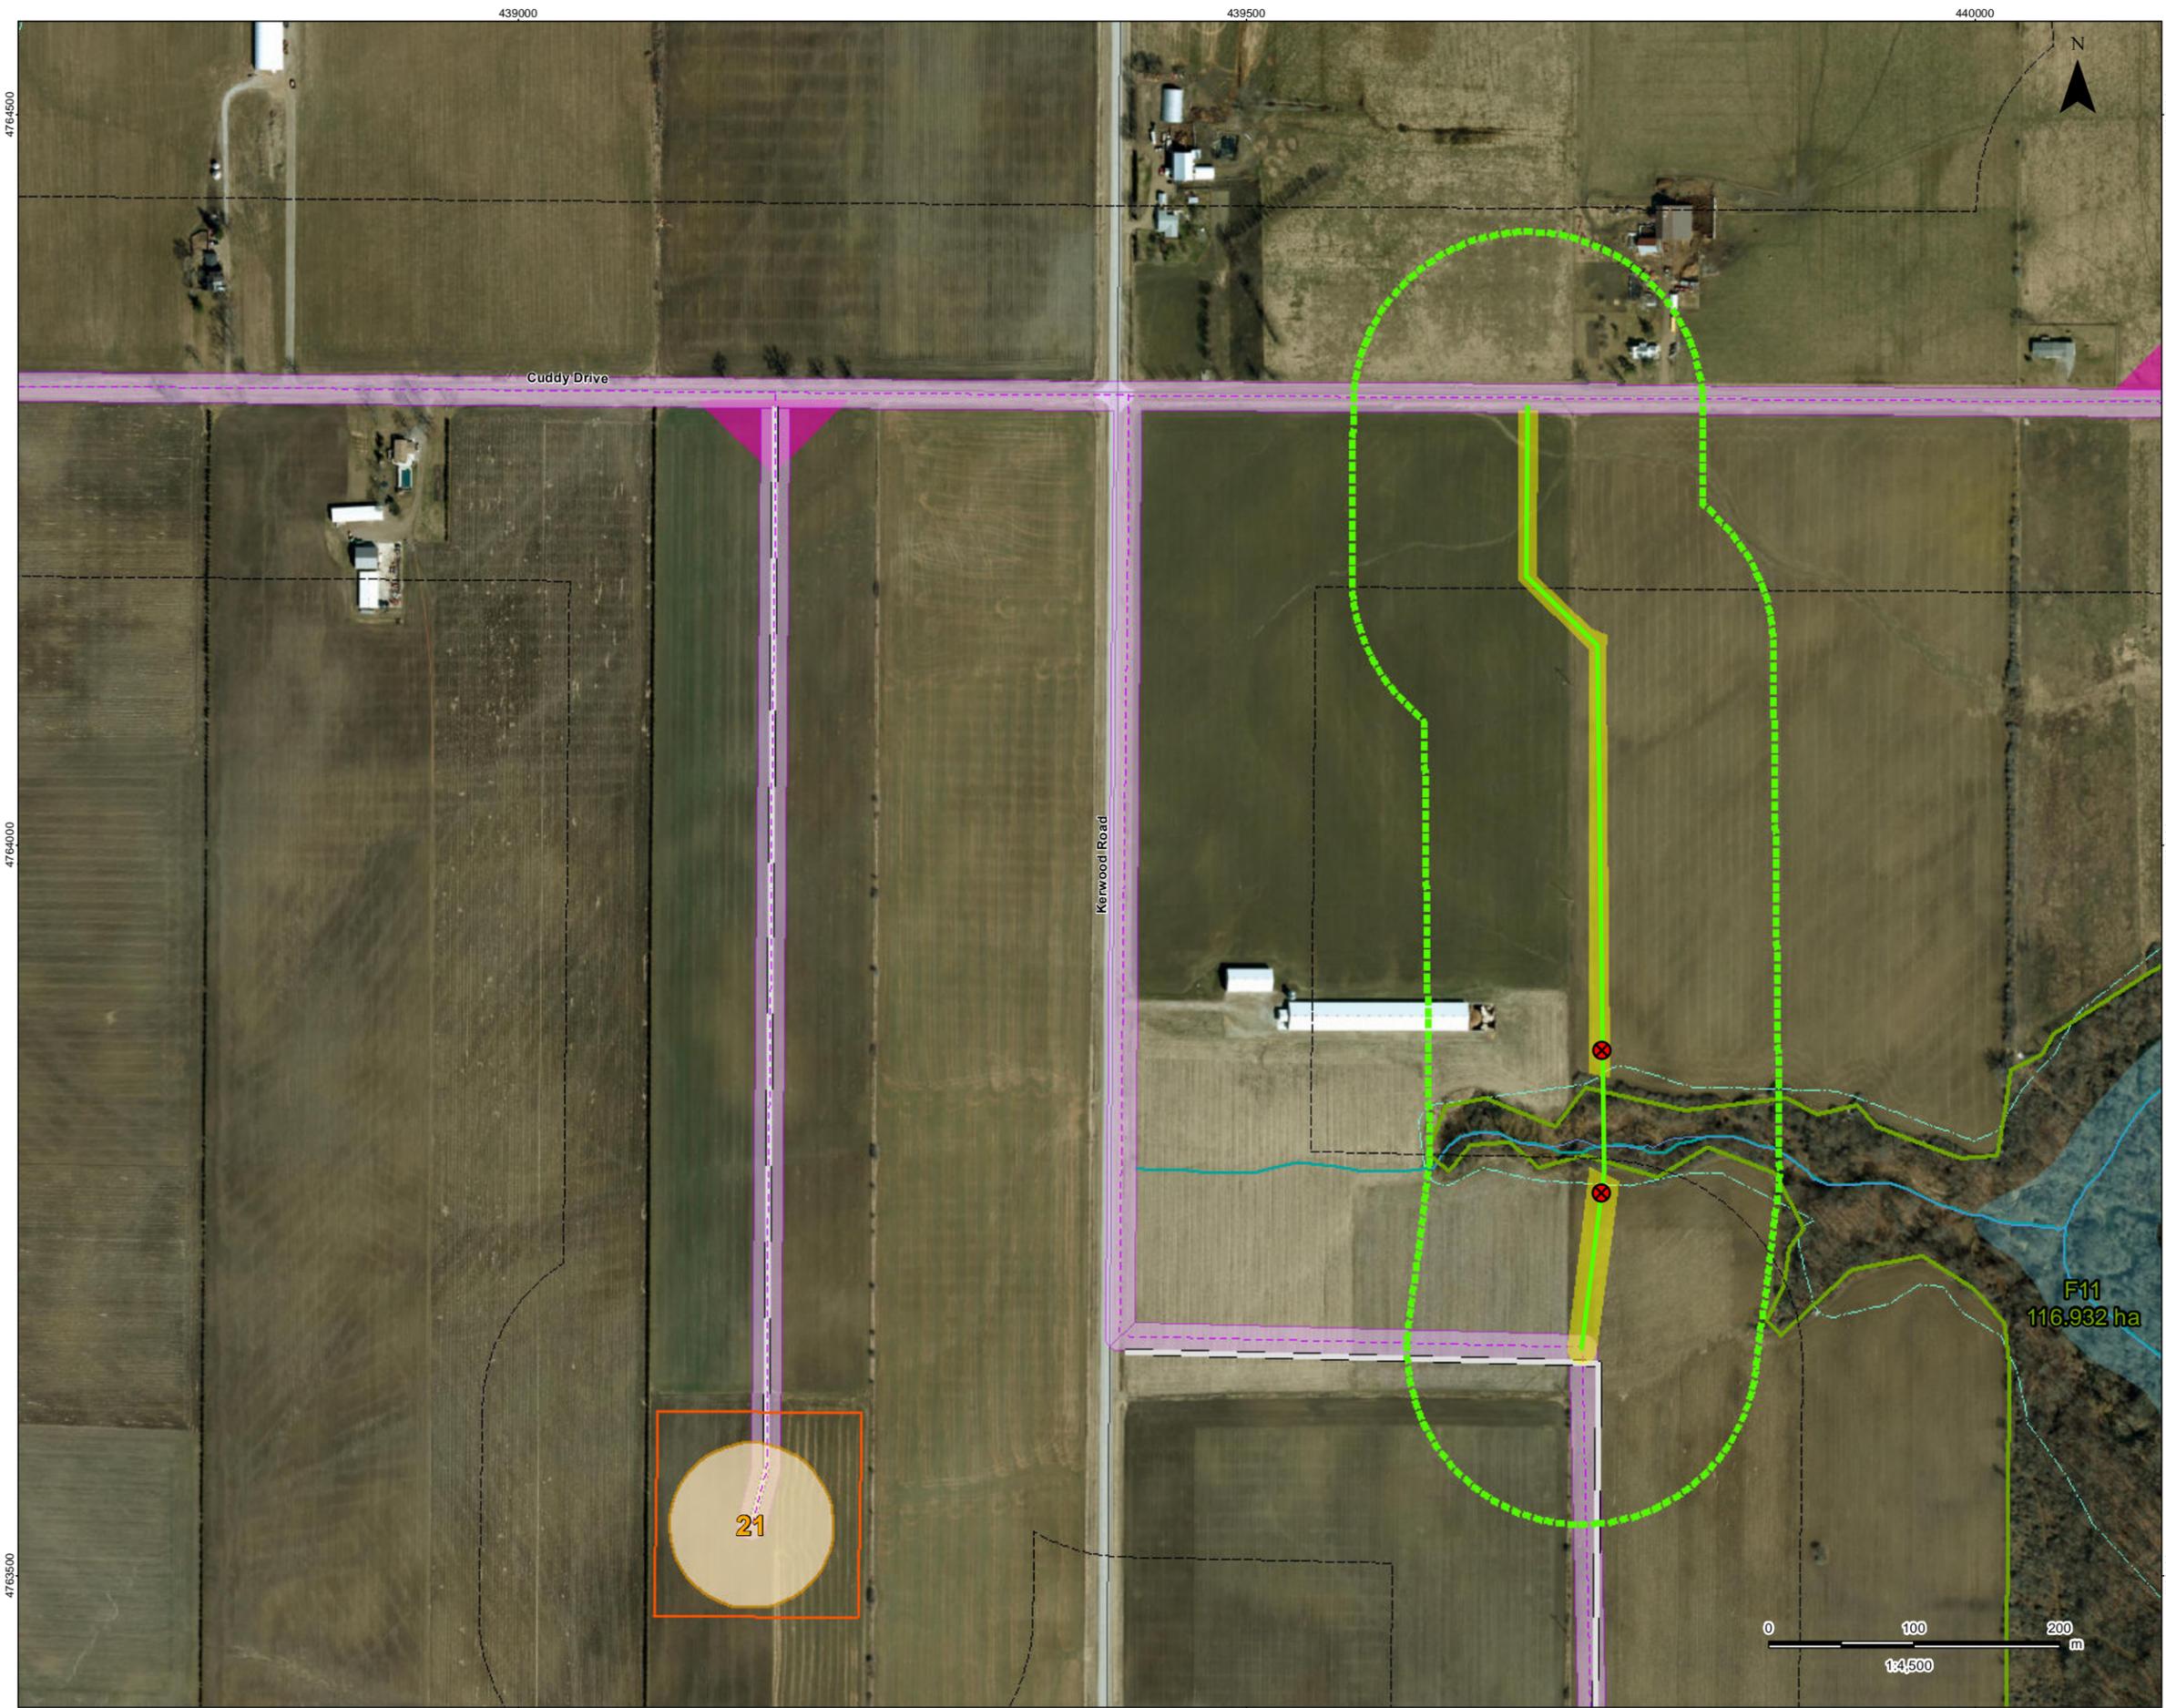
Figure No.
1

Title
Natural Features – Proposed Collector Line Options to Substation

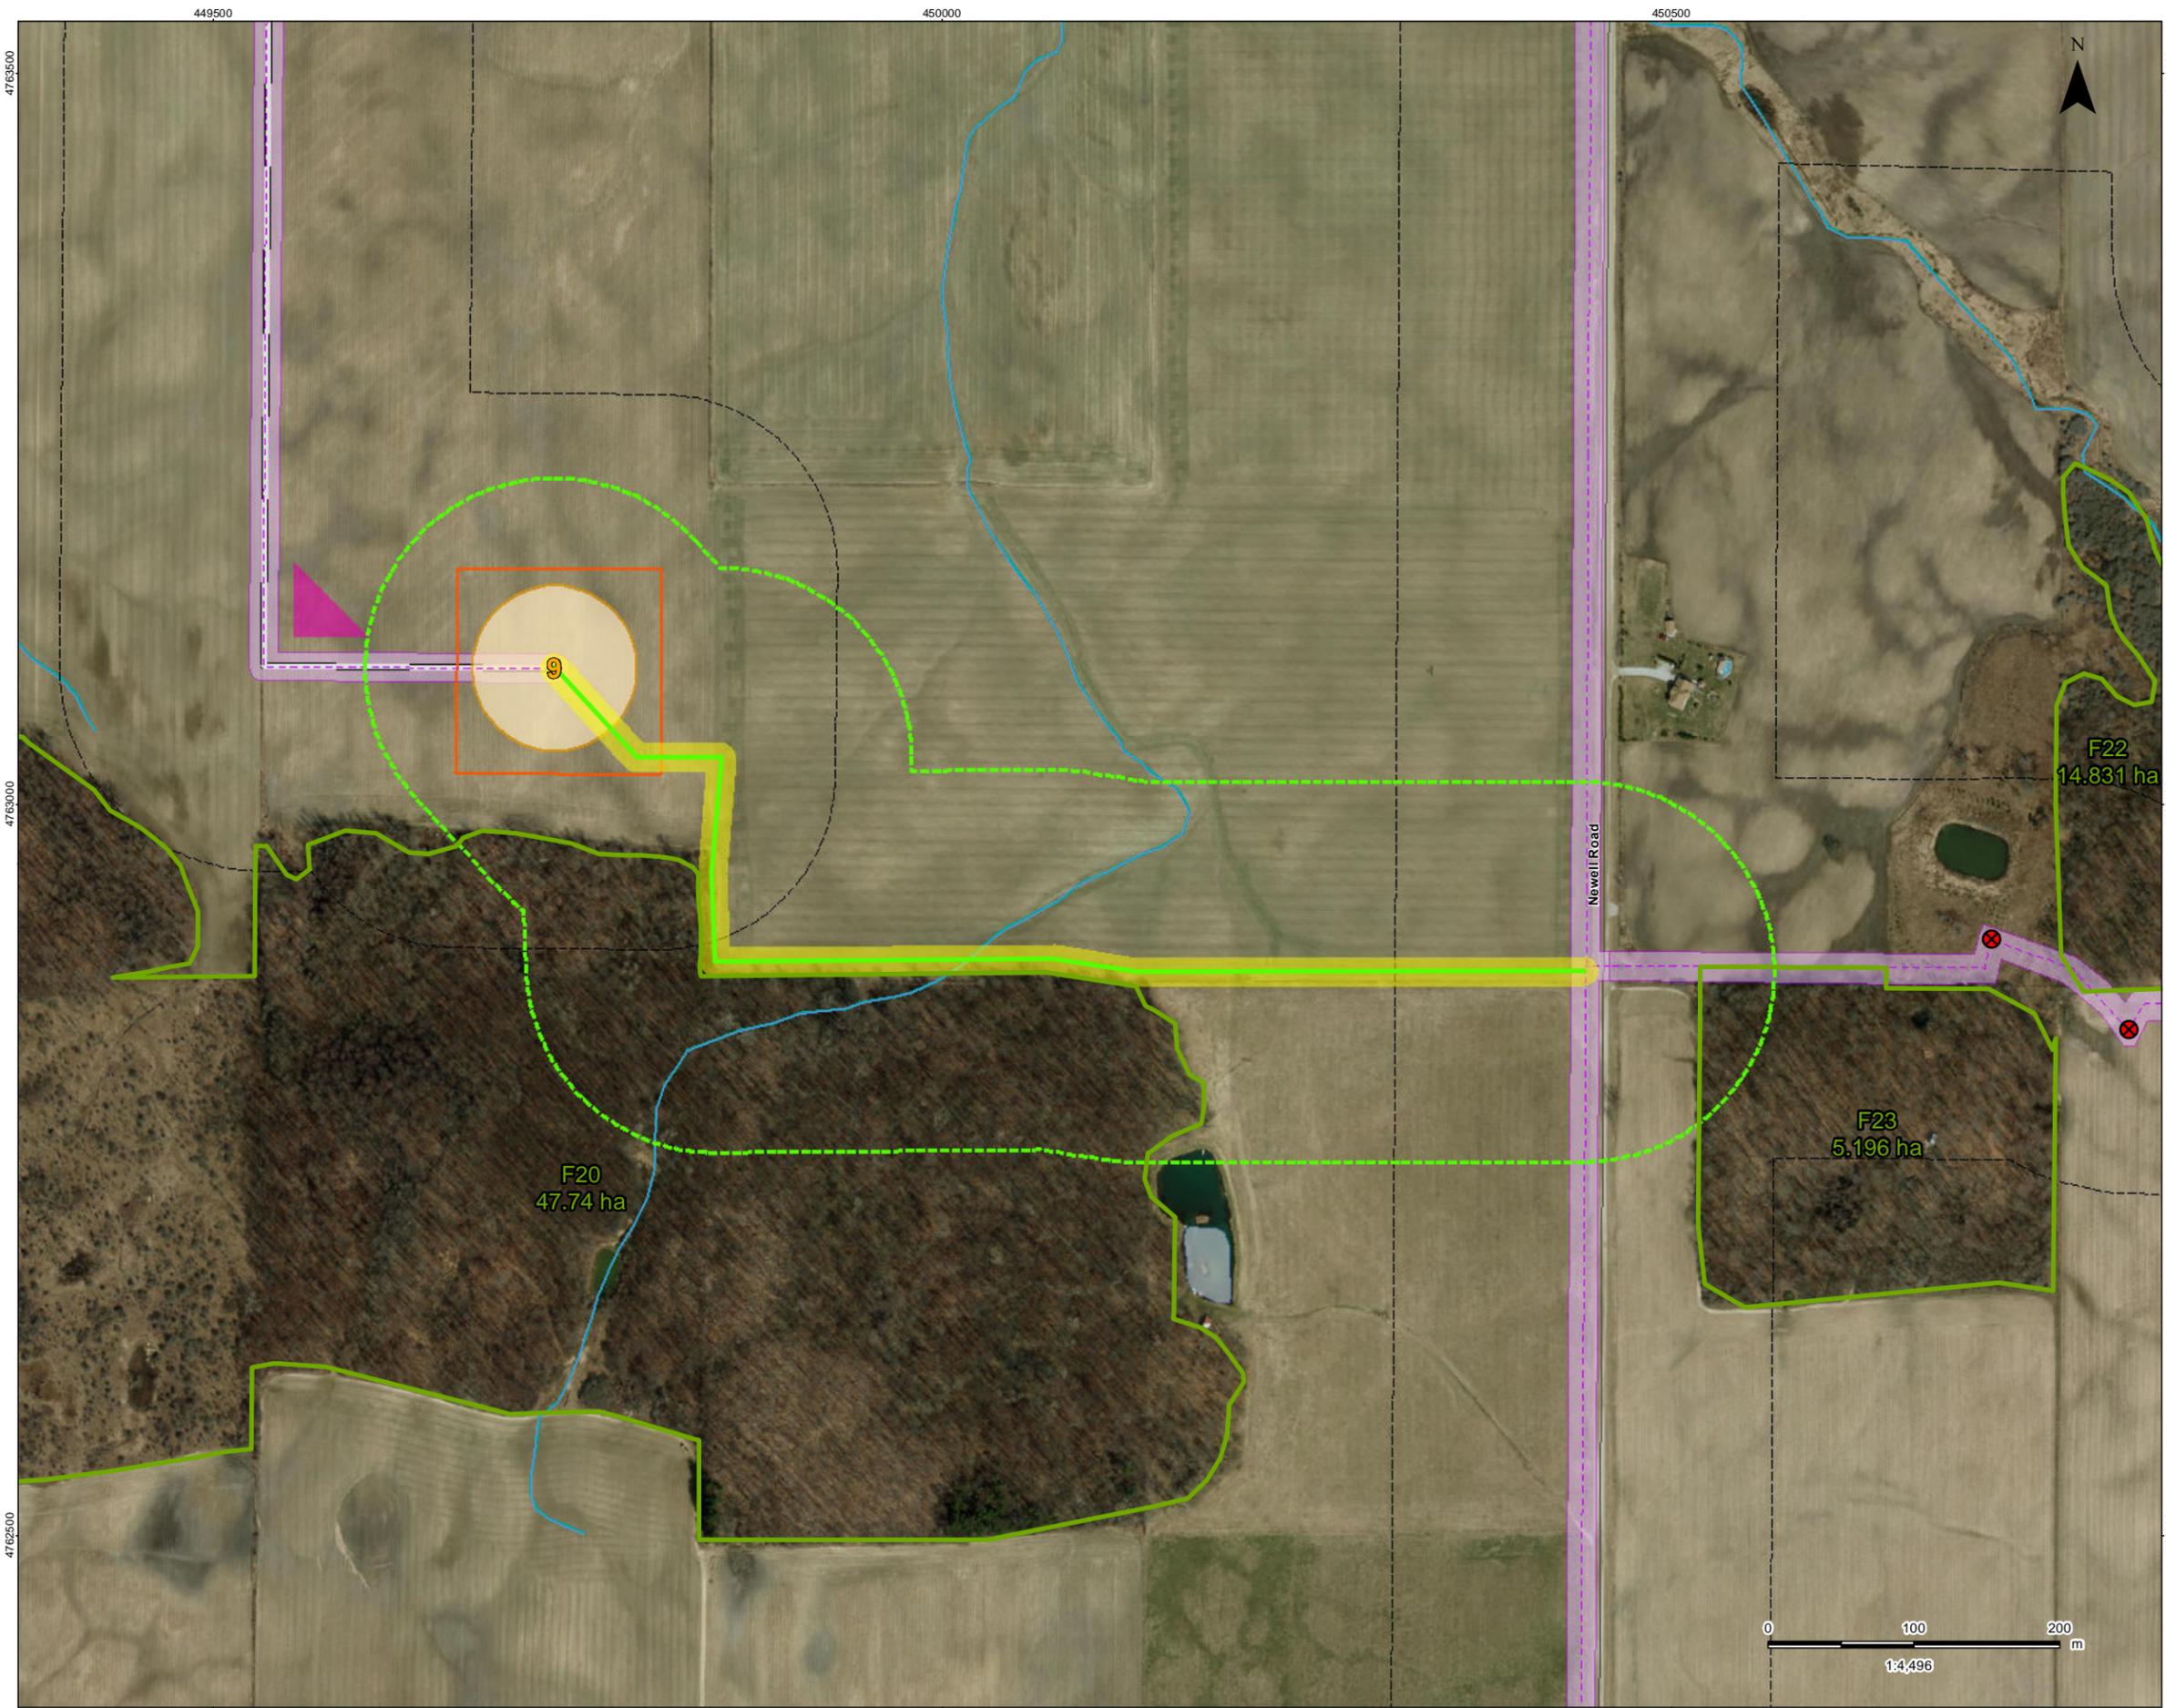
- ### Legend
- New Proposed Collector Option**
 - Collector Line
 - Underground Cable ROW (20m)
 - 120m Zone of Investigation
 - Original/ Assessed Proposed Infrastructure**
 - Proposed Turbine Location
 - Assessed 120m Zone Of Investigation
 - HDD Location
 - Access Road
 - Underground Collector Line
 - Truck Turning ROW
 - Turbine Laydown Area
 - Underground Cable ROW (20m)
 - Existing Features**
 - Expressway / Highway
 - Road
 - Watercourse
 - Waterbody
 - Floodplain (ABCA)
 - Natural Feature (Stantec)

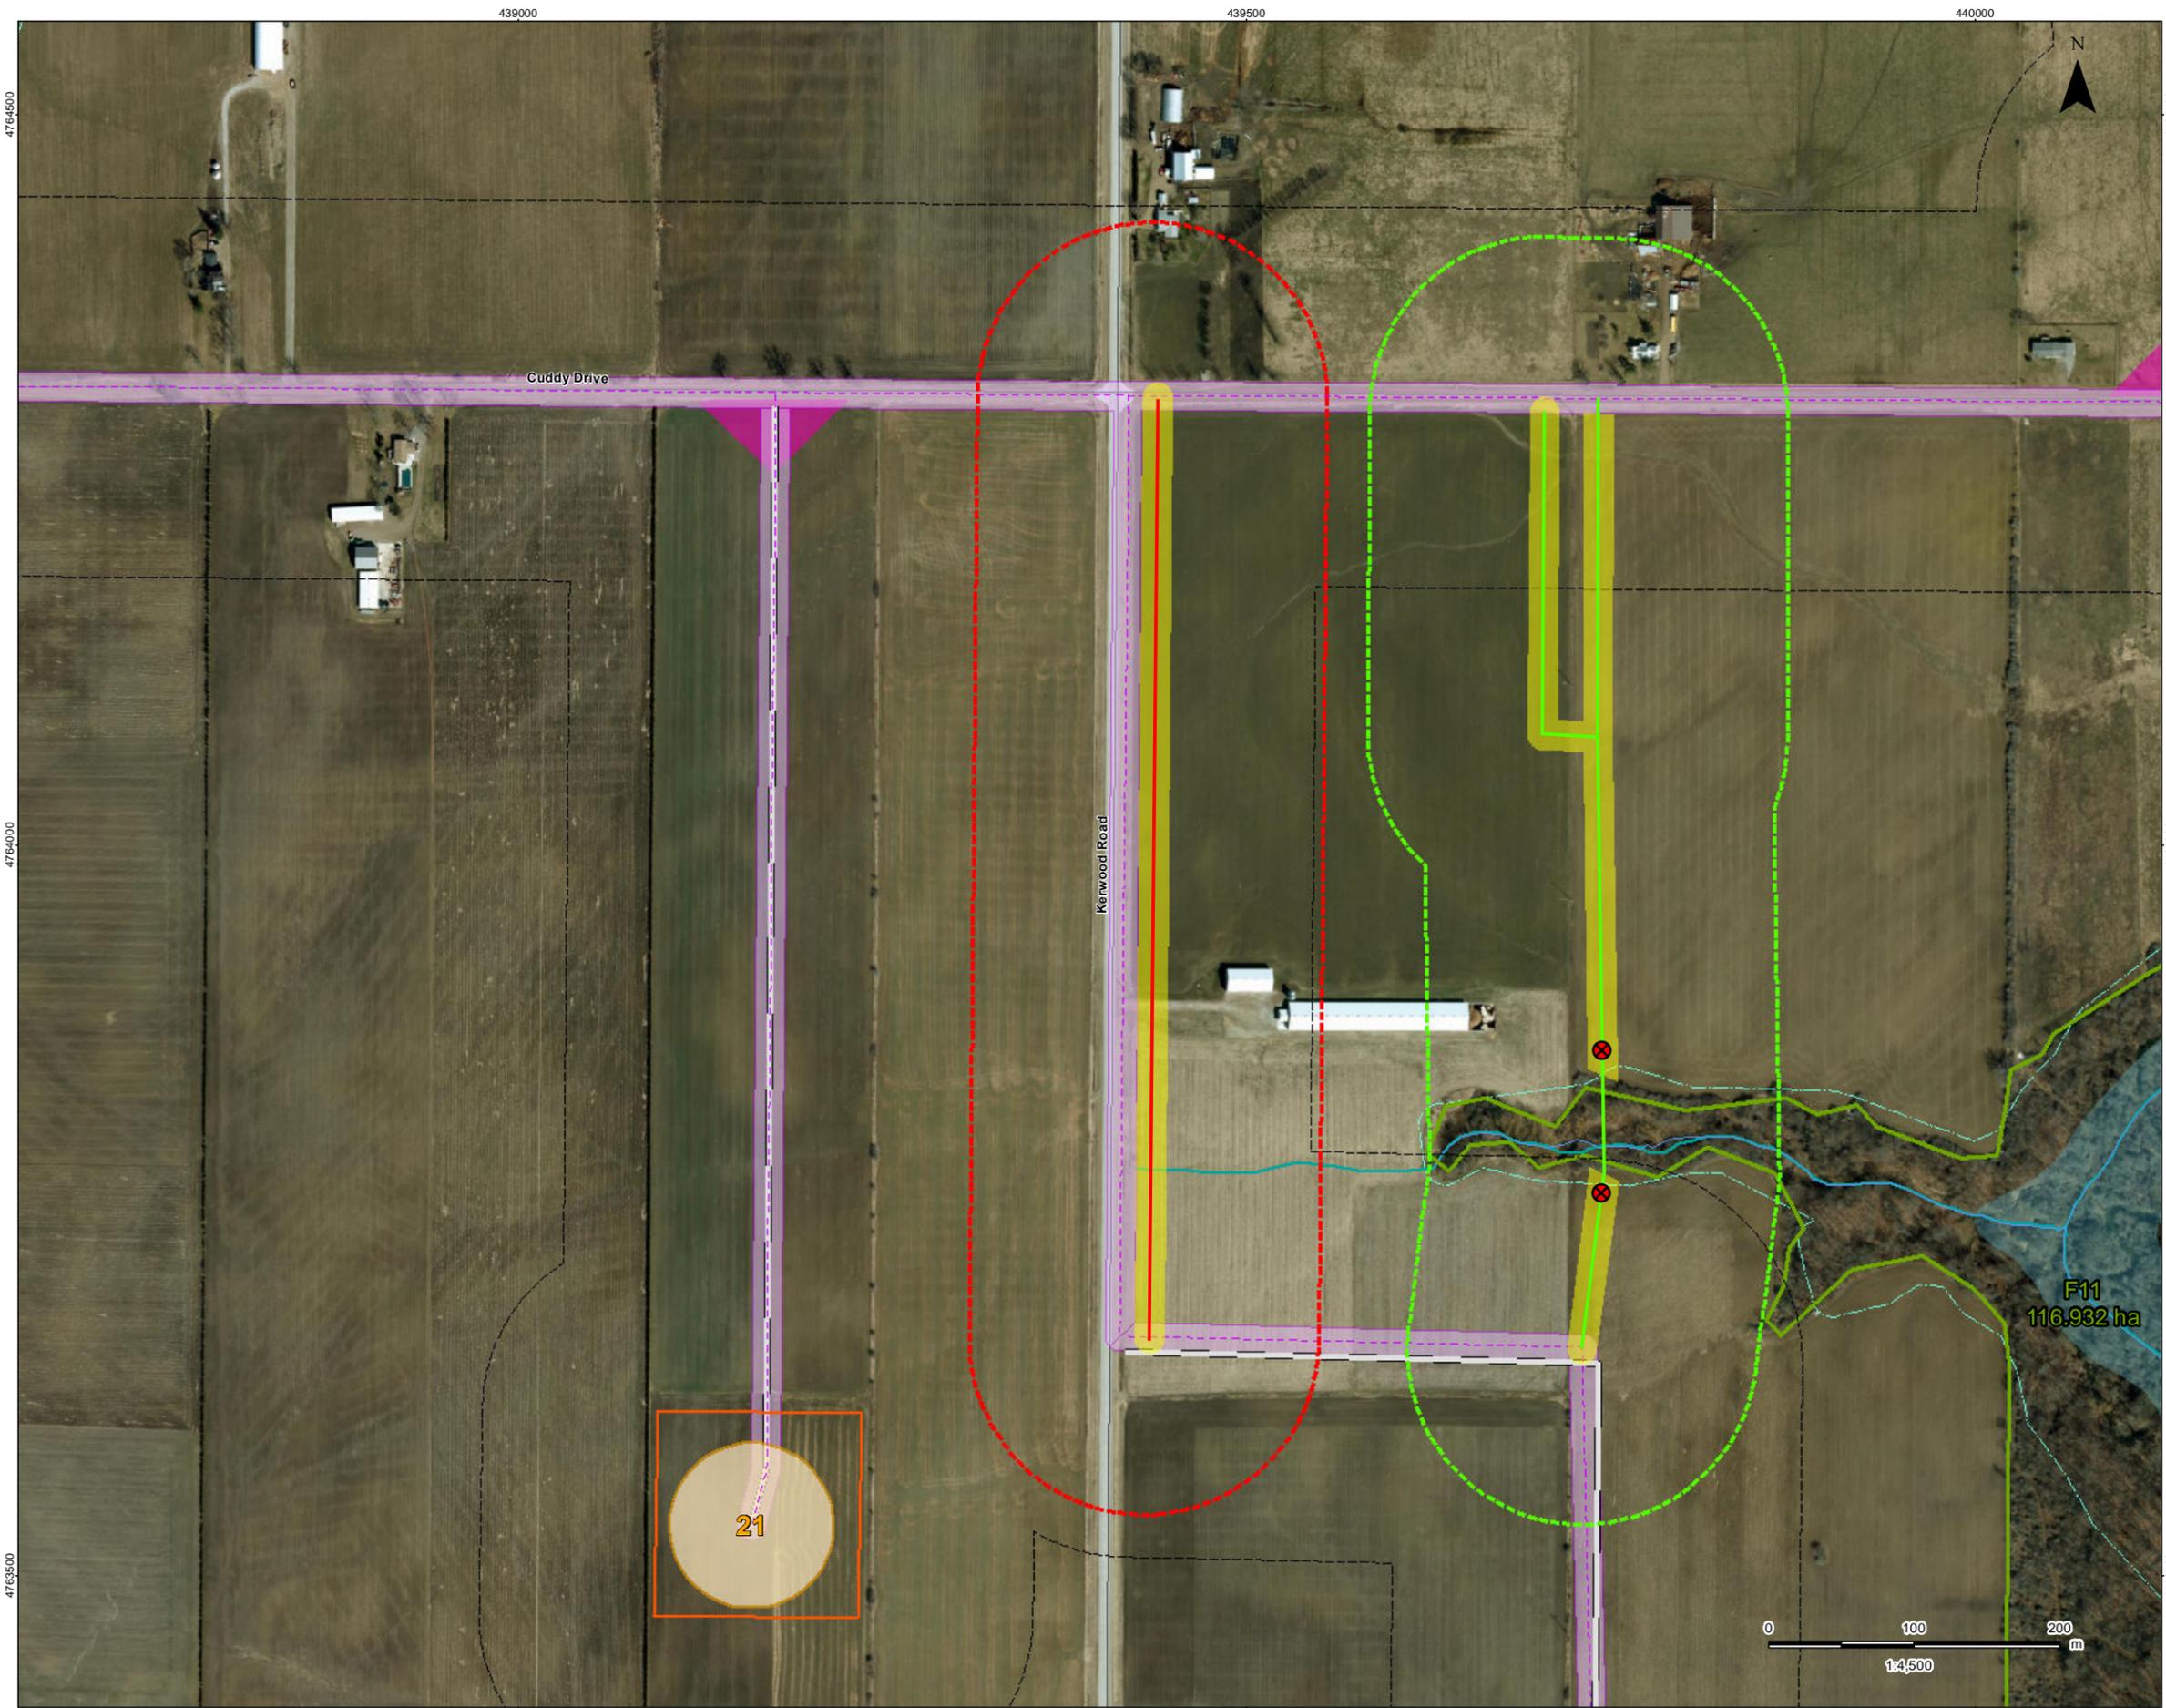
- ### Legend
- New Proposed Collector Options**
 - Collector Line- Option 1
 - Collector Line- Option 2
 - Underground Cable ROW (20m)
 - HDD Location
 - 120m Zone of Investigation- Collector Option 1
 - 120m Zone of Investigation- Collector Option 2
 - Original/ Assessed Proposed Infrastructure**
 - Proposed Turbine Location
 - Assessed 120m Zone Of Investigation
 - Access Road
 - Underground Collector Line
 - Truck Turning ROW
 - Turbine Laydown Area
 - Underground Cable ROW (20m)
 - Existing Features**
 - Expressway / Highway
 - Road
 - Watercourse
 - Waterbody
 - Floodplain (ABCA)
 - Natural Feature (Stantec)
 - Regulation Limit (ABCA)

Title
Natural Features – Proposed Collector Line Options to Substation

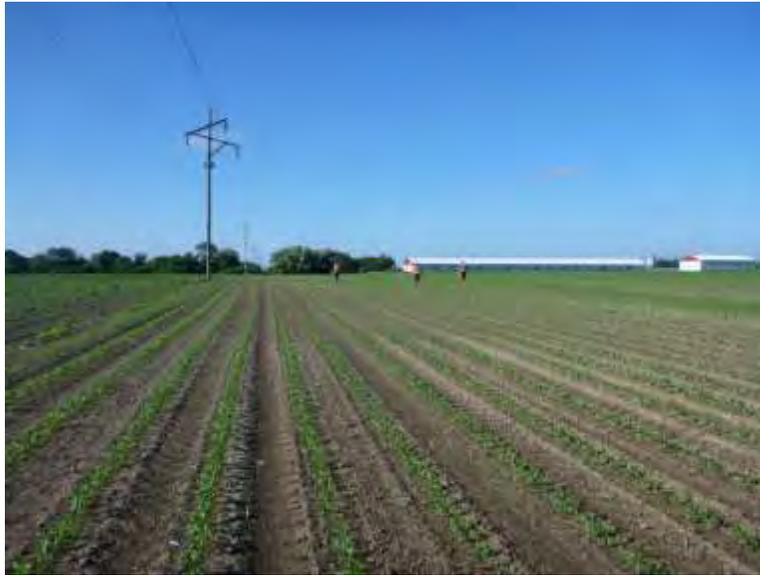
Photo 1: Pedestrian Survey, assessed at 5 metre intervals, facing south

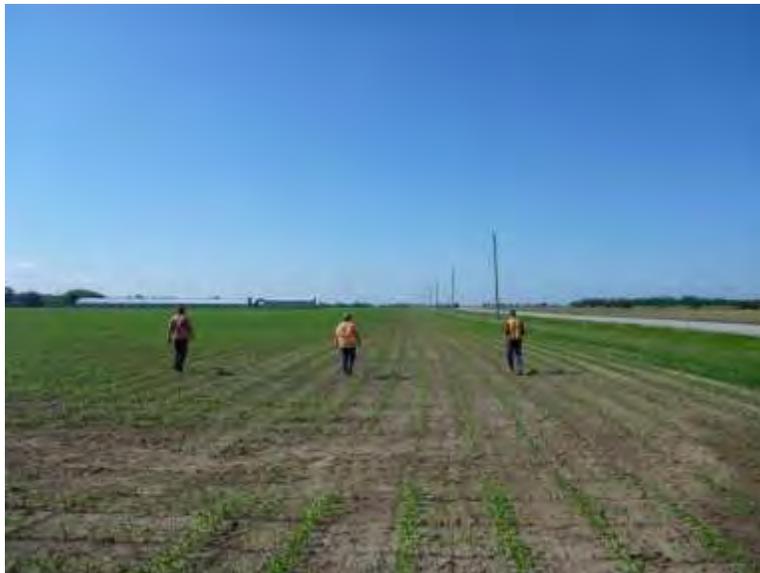
Photo 2: Pedestrian Survey, assessed at 5 metre intervals, facing south

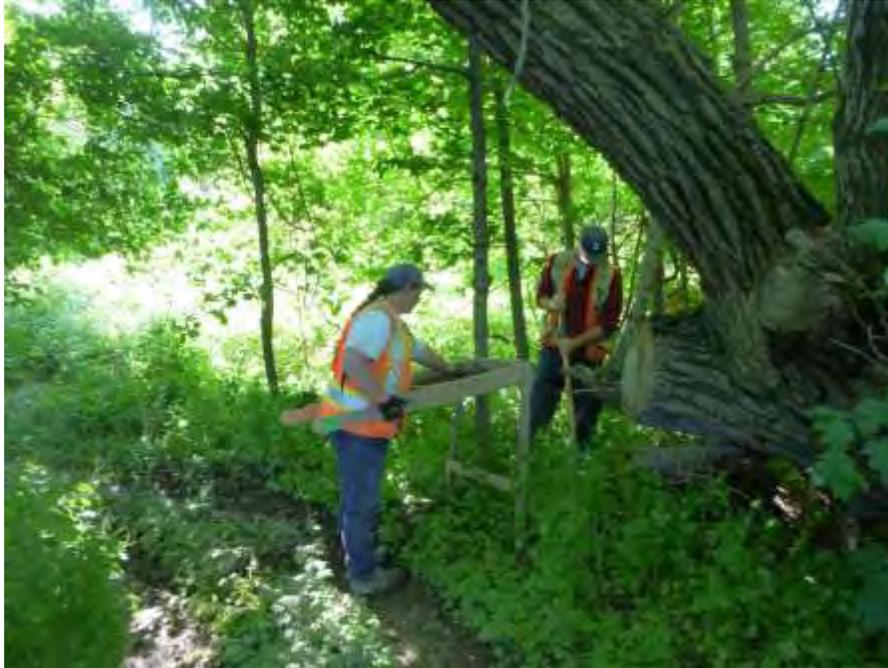
Photo 3: Test Pit Survey, assessed at 5 metre intervals, facing southeast

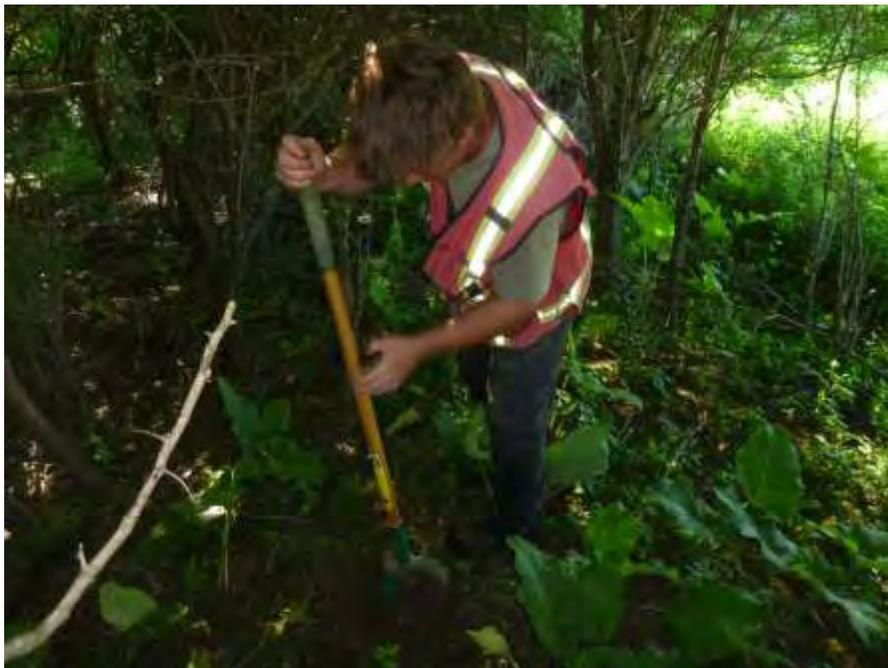
Photo 4: Test Pit Survey, assessed at 5 metre intervals, facing southeast

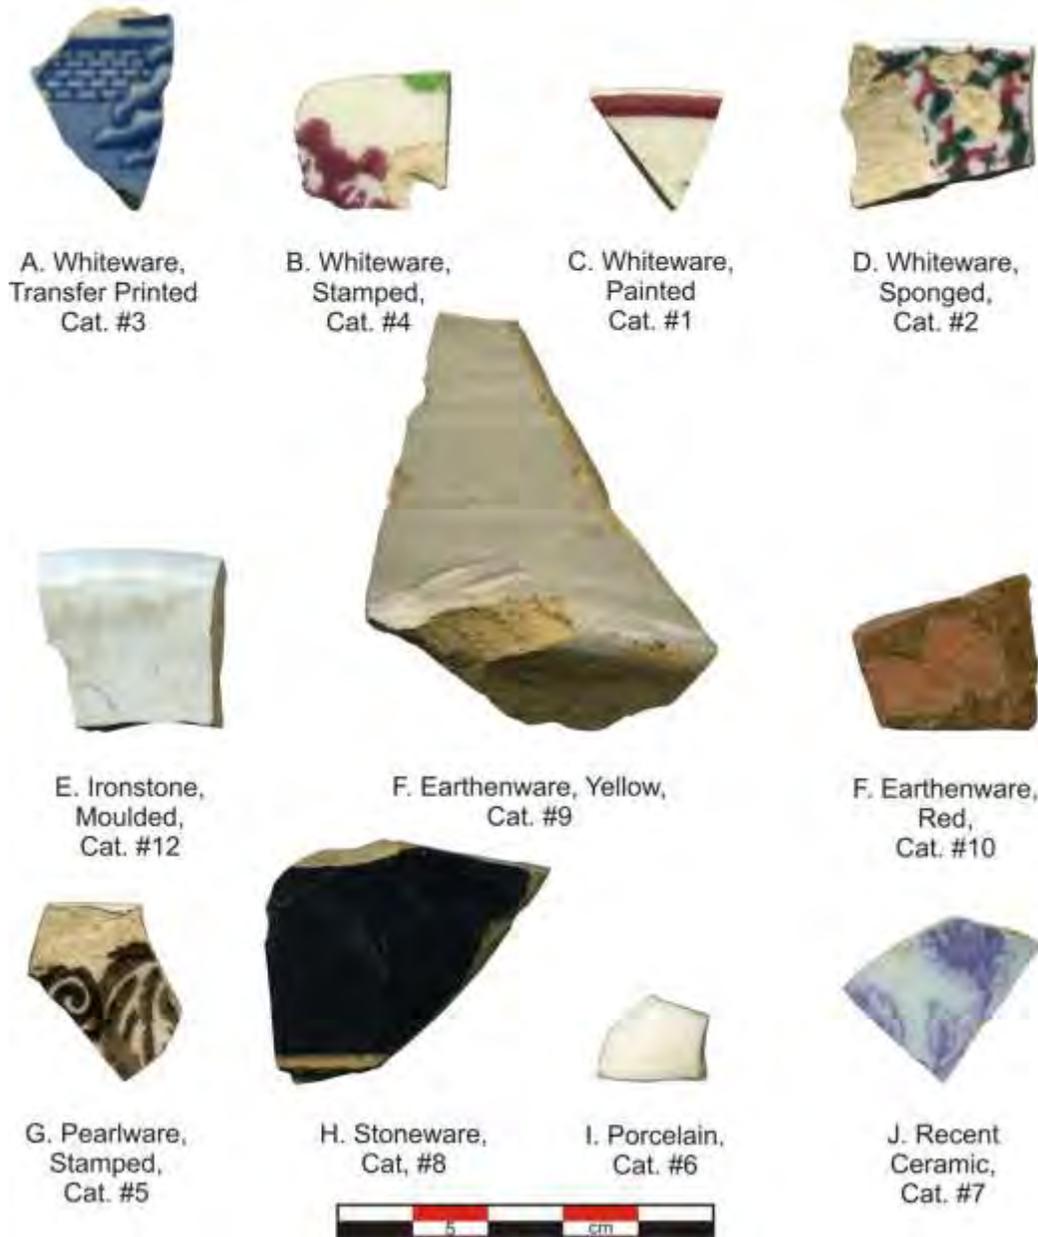
Plate 1: Sample of Historic Euro-Canadian Ceramic Artifacts from Location 2 (AgHk-166)

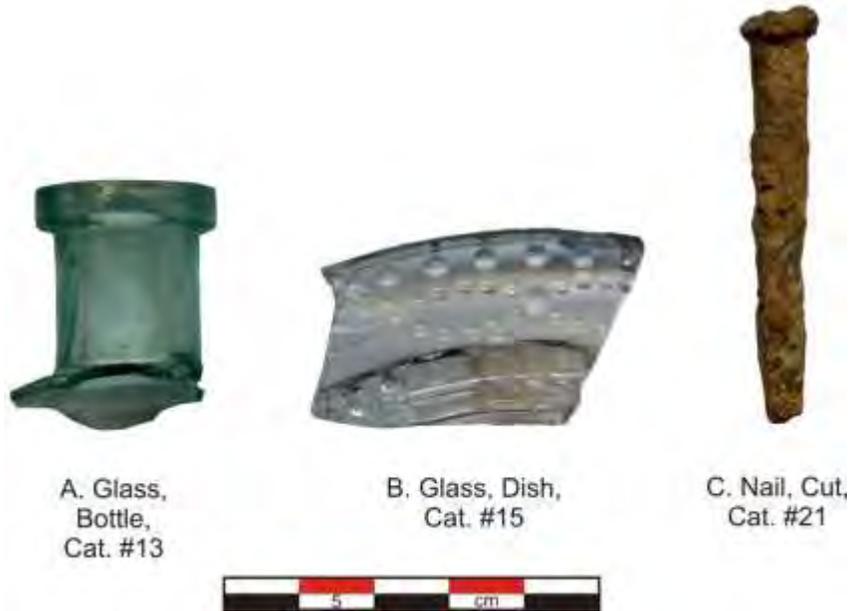
Plate 2: Sample of Historic Euro-Canadian Household and Structural Artifacts from Location 2 (AgHk-166)

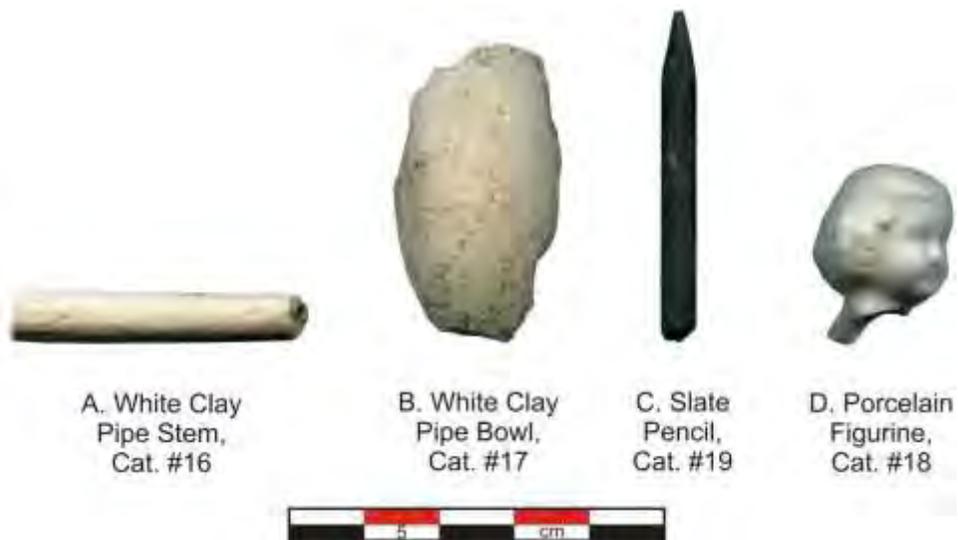
Plate 3: Sample of Historic Euro-Canadian Personal Artifacts from Location 2 (AgHk-166)

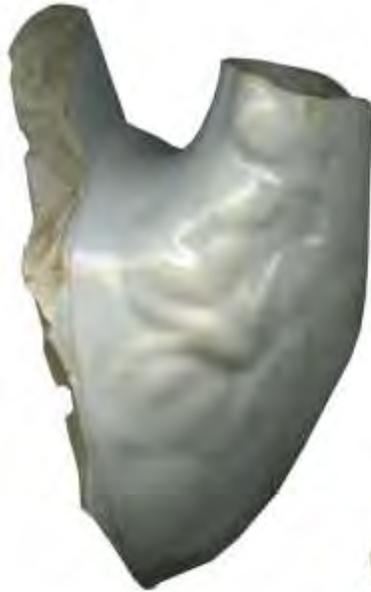
Plate 4: Sample of Historic Euro-Canadian Ceramic Artifacts from Location 3 (AgHk-167)

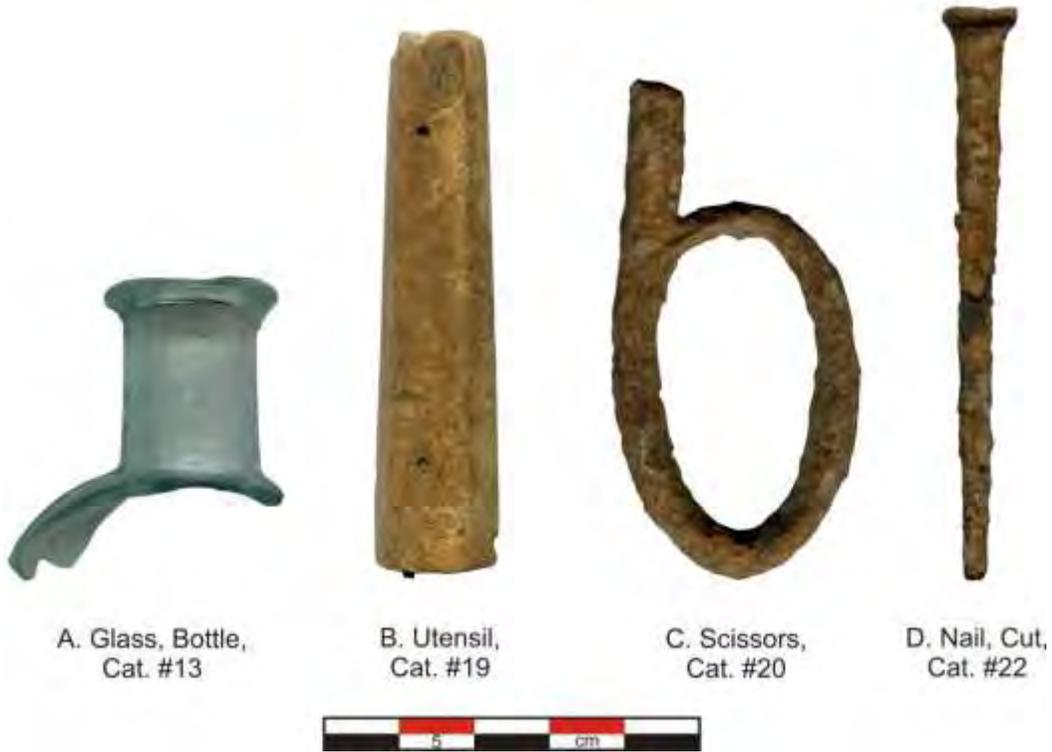
Plate 5: Sample of Historic Euro-Canadian Household and Structural Artifacts from Location 3 (AgHk-167)

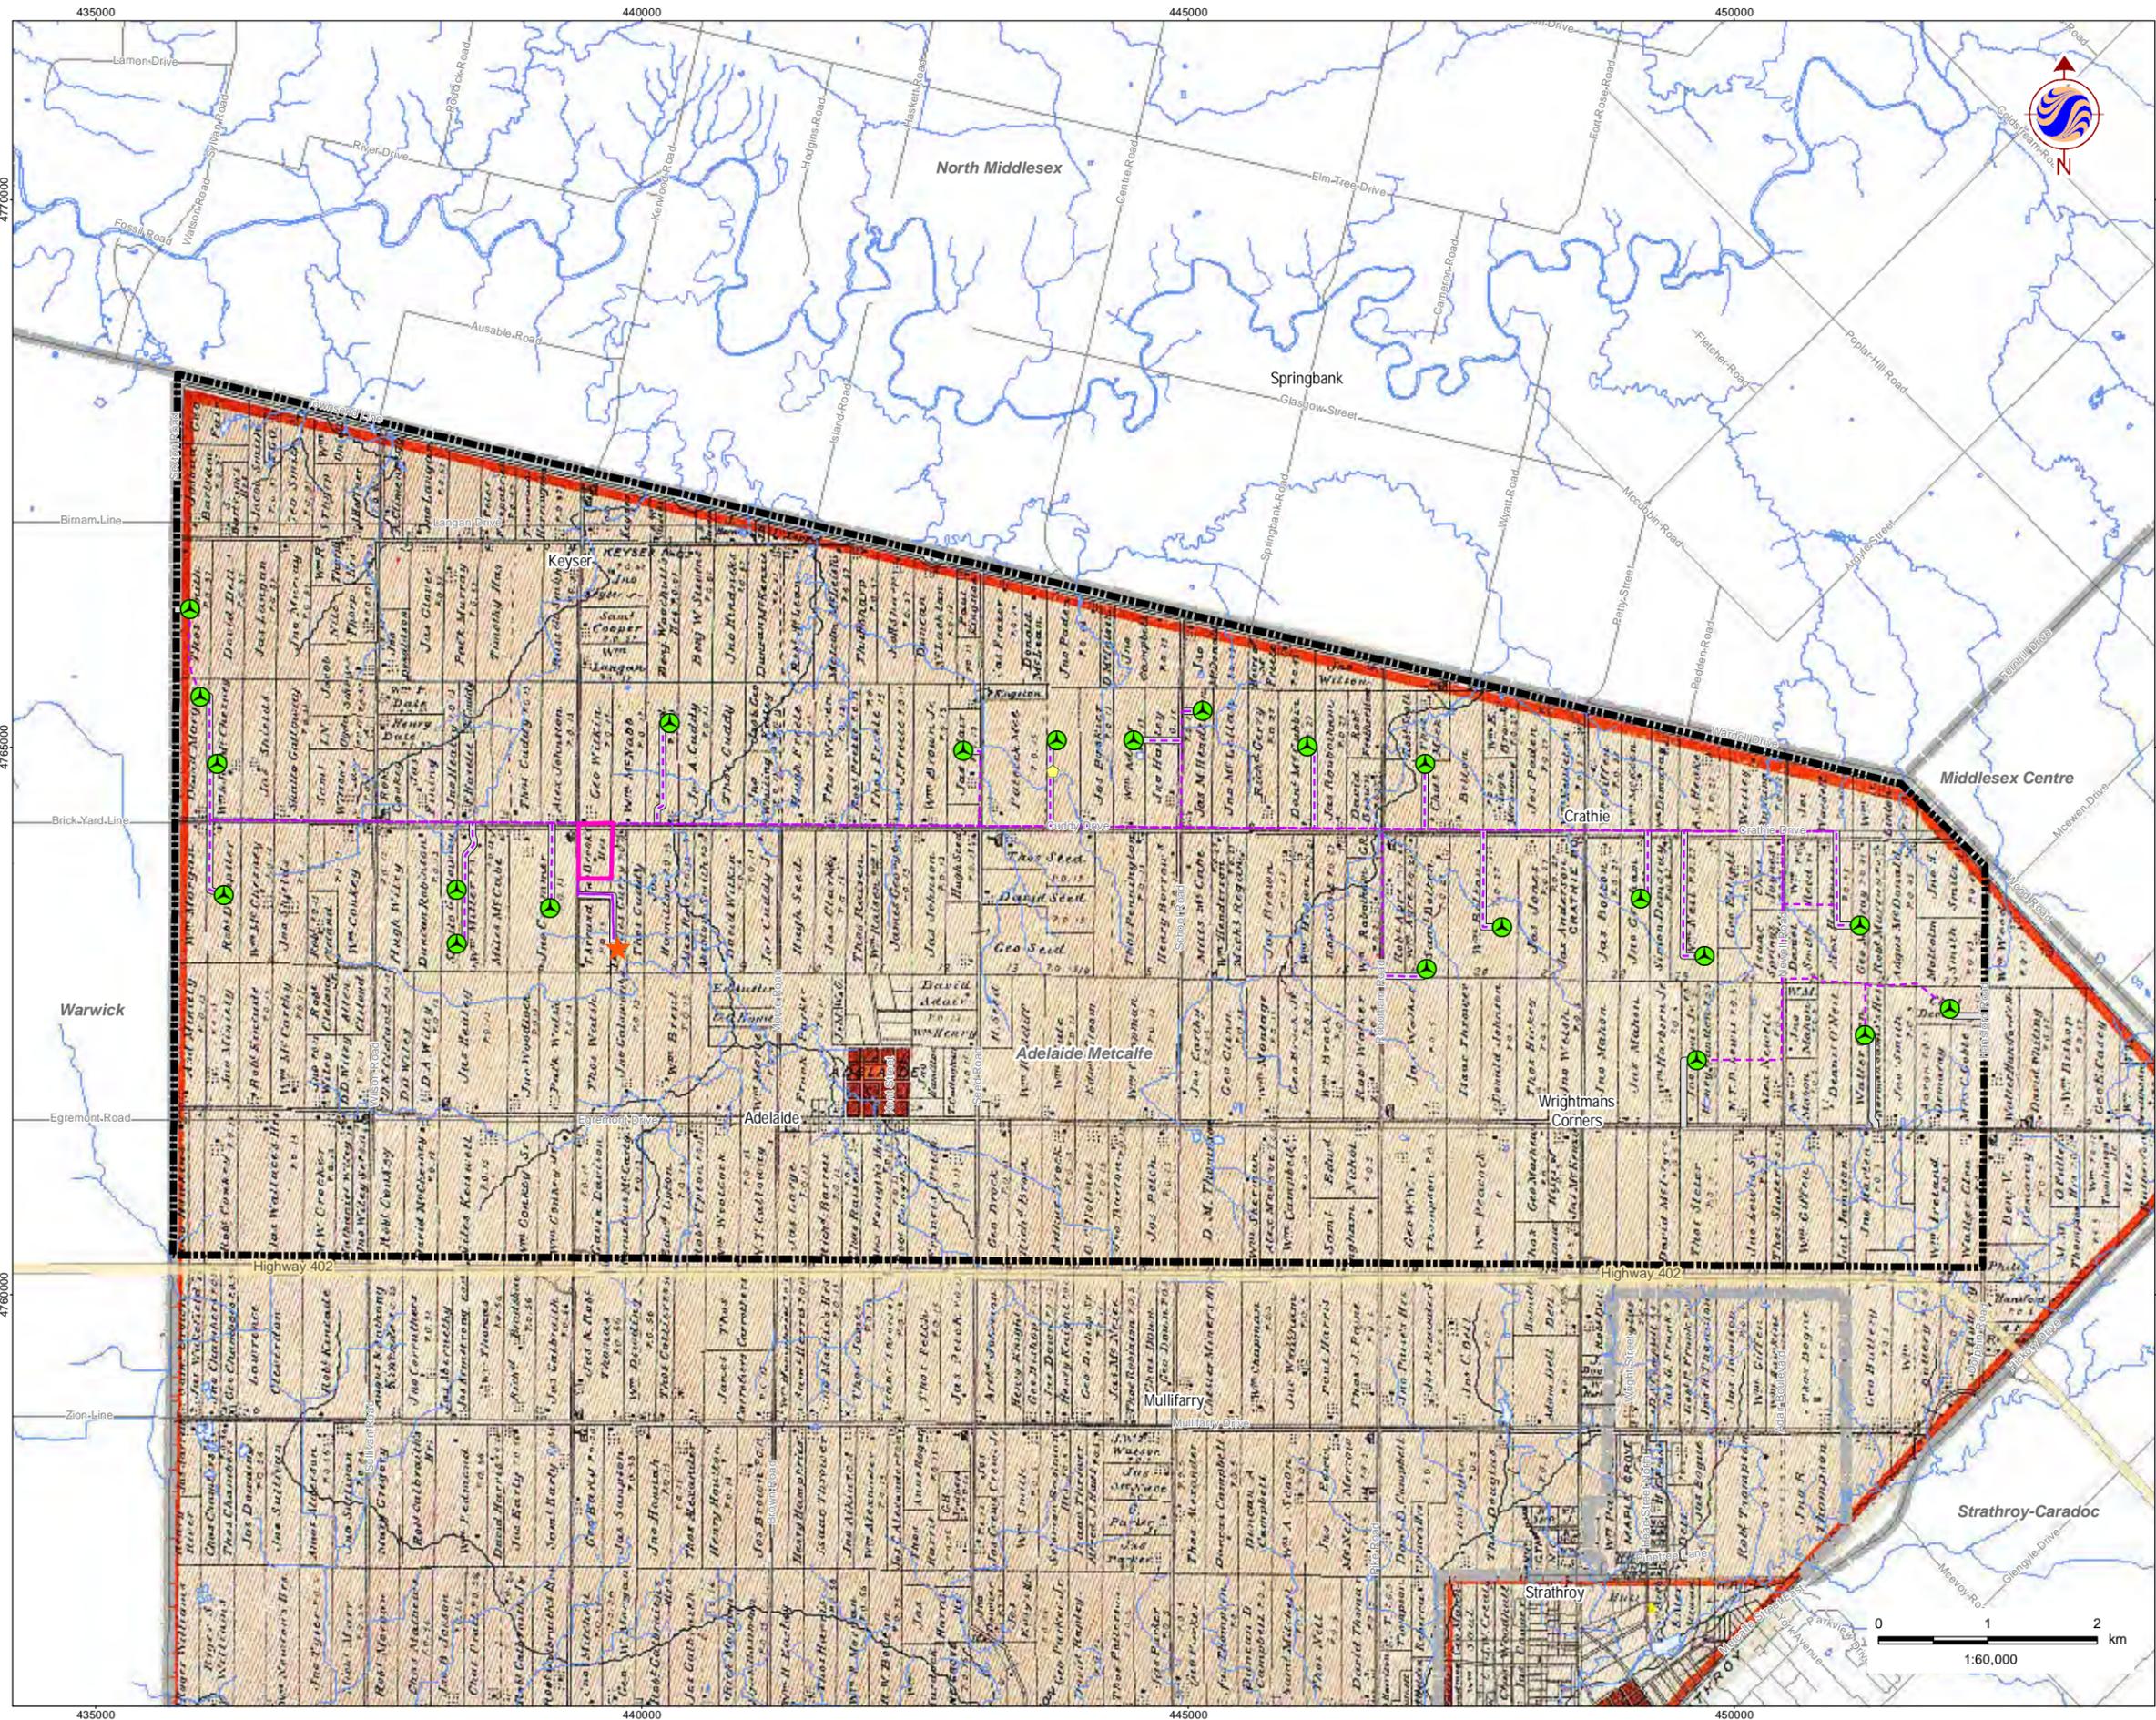
Figure No.
1

Title
Project Location & Study Area
